ON THE LEVEL INSPECTION SERVICE, LLC

OTL RESIDENTIAL TEMPLATE

1234 Main Street
Franklin, WI 53132

11/02/2023 9:00AM

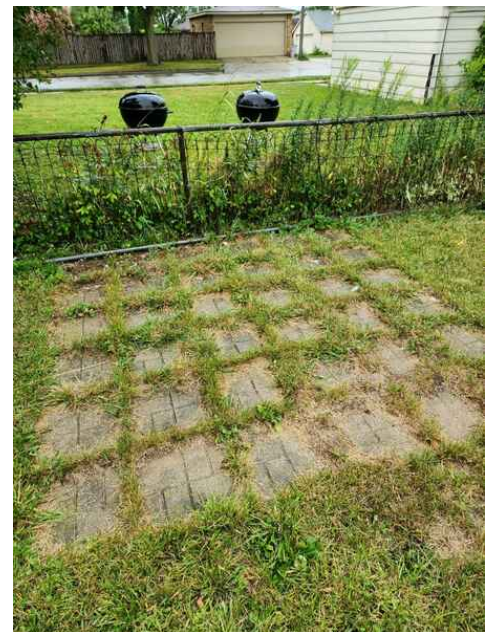
3.3.1 Decks, Balconies, and Patios

PATIO OVERGROWTH

The patio area is overgrown with grass and weeds. Recommend cleaning up the area.

Contact a handyman or DIY project

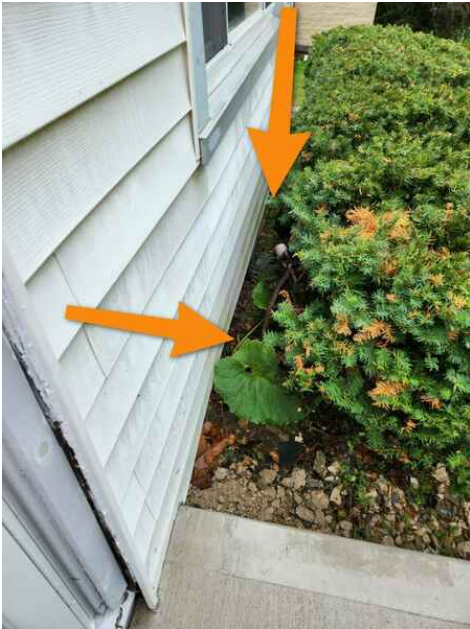
3.5.1 Landscaping affecting foundation

NEGATIVE GRADING

Grading is sloping towards the home in the front of the home. This could lead to water intrusion and foundation issues. Recommend qualified landscaper or foundation contractor regrade so water flows away from home.

Contact a qualified landscaping contractor

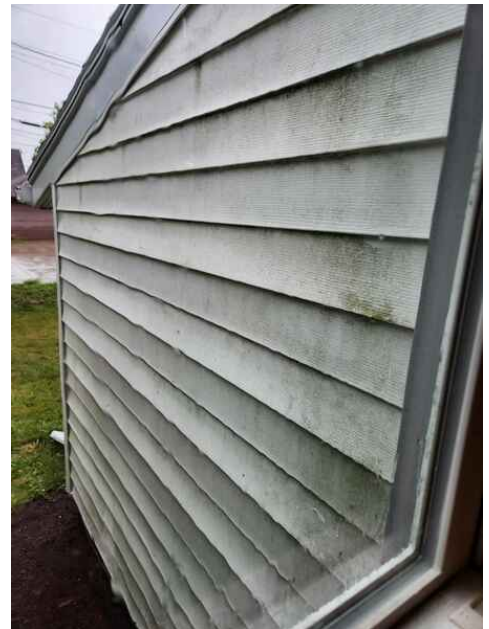
4.2.1 Siding, Flashing & Trim

MILDEW/ALGAE

There are signs of algae and/or mildew on the siding. This is a cosmetic issue and is not uncommon especially on shaded portions of the home. Recommend that said areas be washed or cleaned on a regular basis.

Contact a qualified professional.

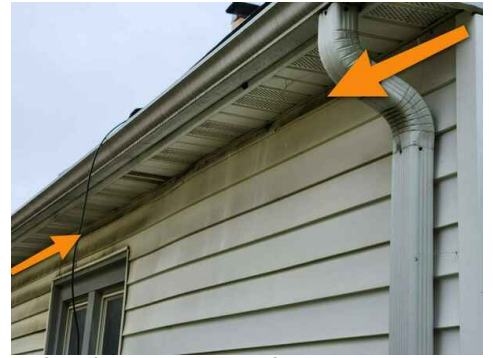
Left Side near Front of Home

WARPING/BUCKLING

Vinyl siding was warping or buckling in areas. This is often as a result of nailing siding boards too tight to the home, preventing expansion/contraction. Recommend a qualified siding contractor evaluate and repair.

Contact a qualified professional.

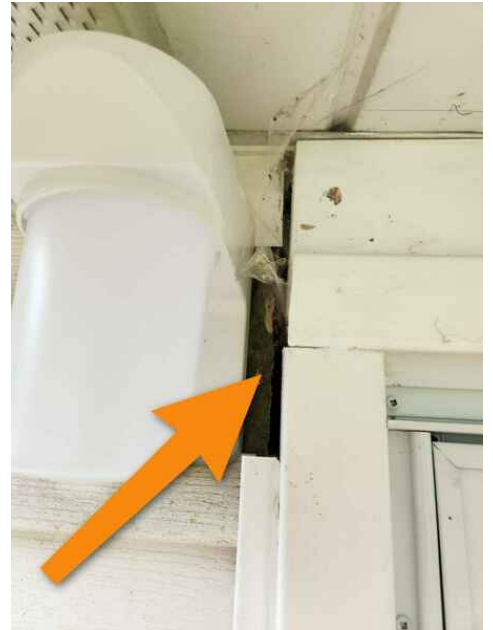
Rear Entrance up at light

SIDING AND/OR TRIM MISSING

Siding or trim is missing, and underlayment is showing. Recommend repair as needed.

Contact a handyman or DIY project

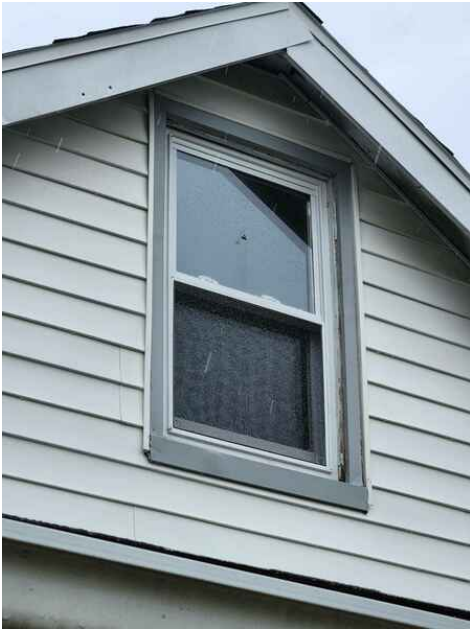
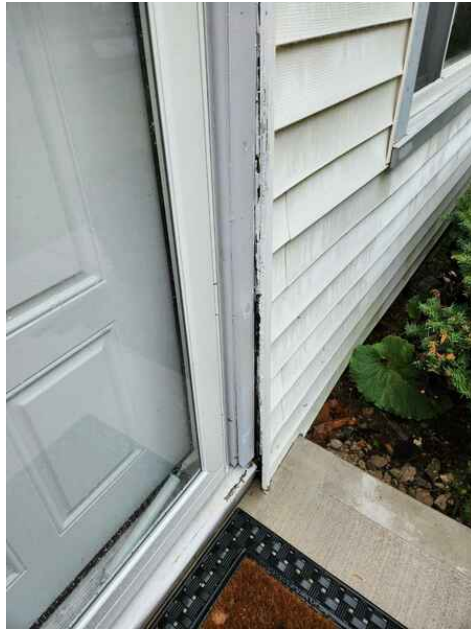
4.2.4 Siding, Flashing & Trim

WOOD ROT

Wood trim at various locations around home have wood rot damage. Recommend replacement with newer and damage free boards.

Upstairs Window Backyard

Main Entrance

Contact a handyman or DIY project

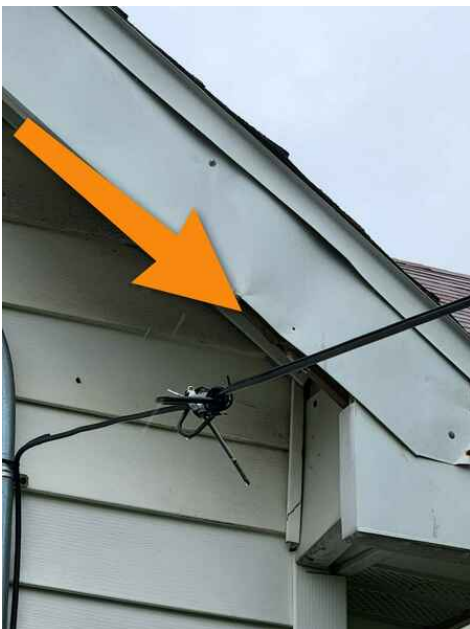
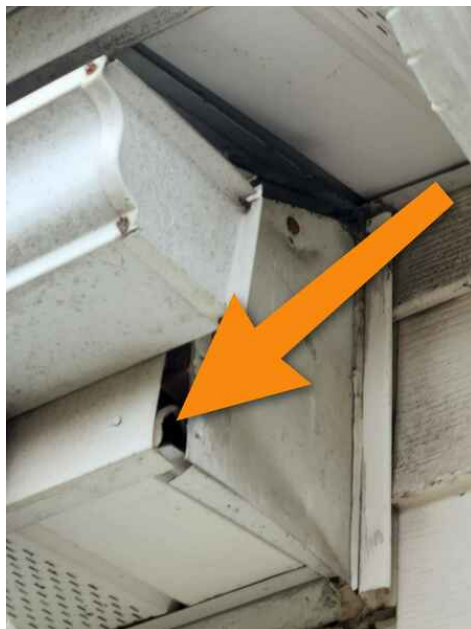
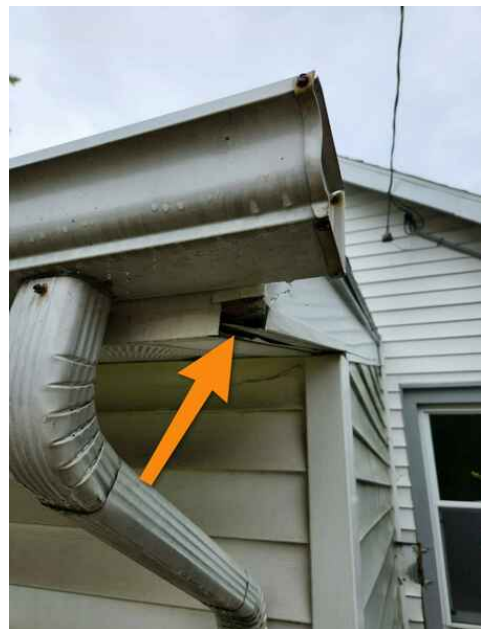
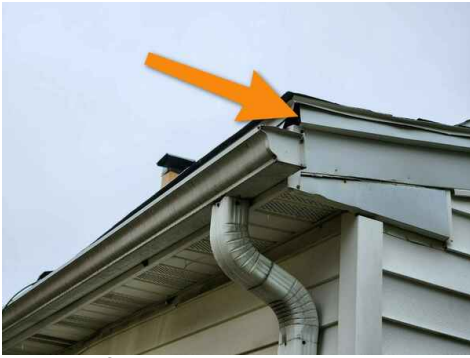
4.3.1 Soffits and Fascia

GAP

There are openings, gaps or holes in fascia which should be repaired. This can allow water intrusion and rodent infestation as well as deterioration of the surrounding material.

Rear of home

Front Left Corner

Contact a qualified handyman.

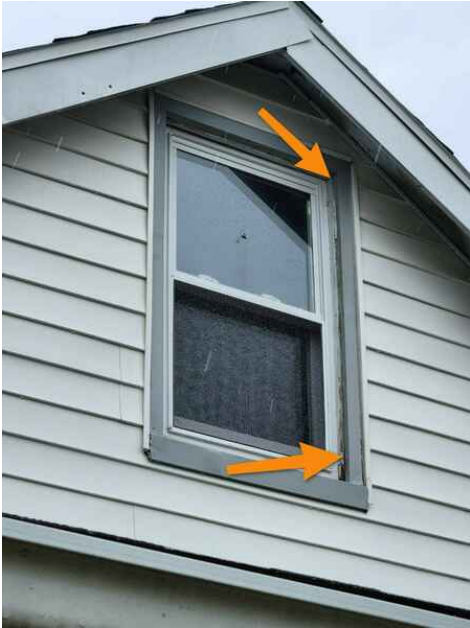
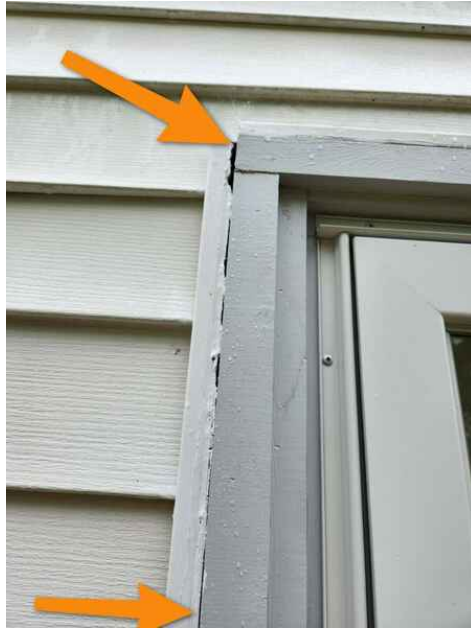
4.4.1 Caulking

CAULKING MAINTENANCE

The caulking maintenance around windows, doors, masonry ledges, corners, and utility penetrations need to be refreshed around the entire home.

Contact a handyman or DIY project

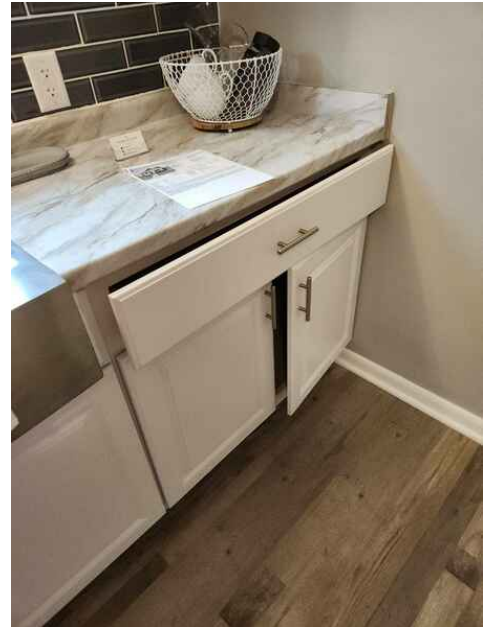
7.2.1 Countertops & Cabinets

CABINET DOOR OR DRAWER MISALIGNED

When a lower cabinet door is opened the drawer above opens. Recommend realigning the cabinet door.

Contact a handyman or DIY project

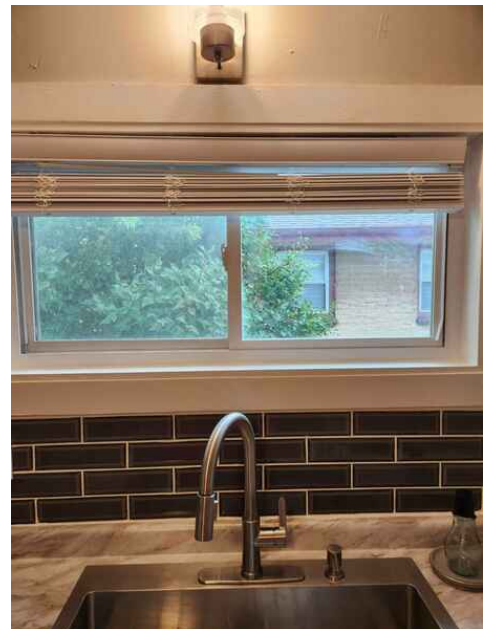
7.4.1 Walls & Ceiling

KITCHEN WINDOW PAINTED SHUT

At the time of inspection the Kitchen window was painted shut and would not open. Recommend repair as needed.

Contact a handyman or DIY project

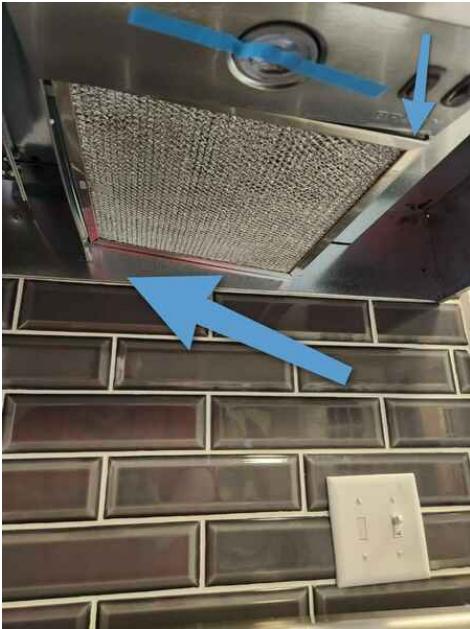
7.5.1 Range/Oven/Cooktop

EXHAUST FILTER NOT PROPERLY INSTALLED

The filter for the Exhaust hood is not properly installed. Recommend repair as need per manufacture instructions.

Recommended DIY Project

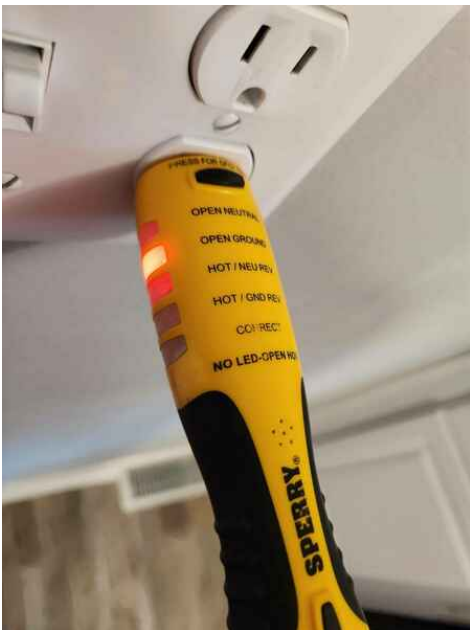
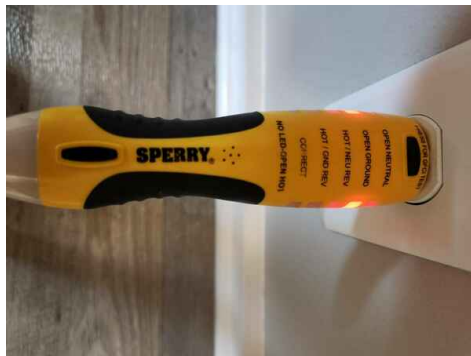
7.7.1 Electrical

OPEN GROUND

The Ground Wire is not properly attached. This is a **Safety Defect**. Recommend repair as needed.

Contact a qualified professional.

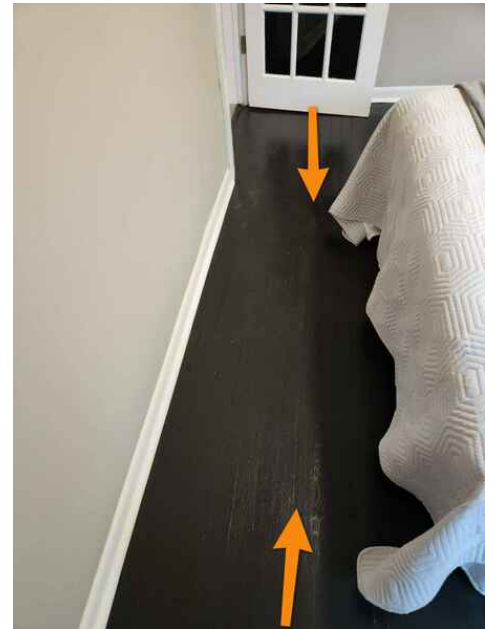
8.4.1 Floors

RISE IN FLOOR

The floor near the wall shared with the Kitchen the floor has a rise. Recommend further evaluation by a Structural Engineer.

Contact a qualified structural engineer.

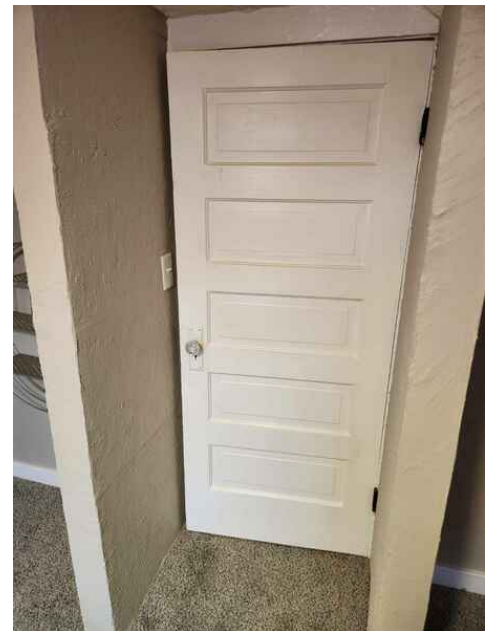
9.1.1 Doors

DOOR MISALIGNED

The door will not close properly and wants to hang up. Recommend repair as needed.

Contact a handyman or DIY project

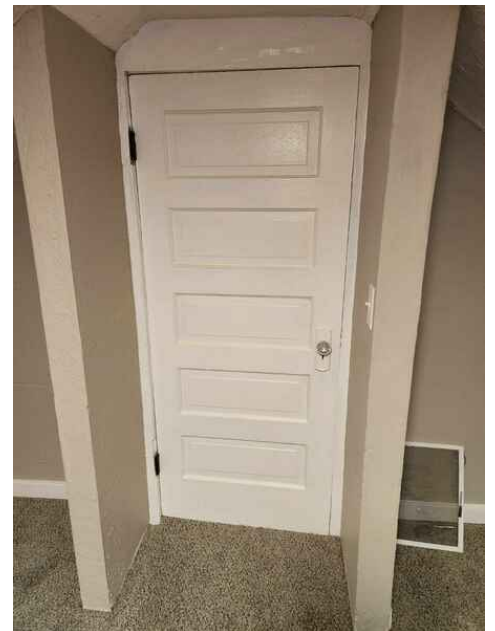
10.1.1 Doors

DOOR MISALIGNED

The door will not close properly and wants to hang up. Recommend repair as needed.

Contact a handyman or DIY project

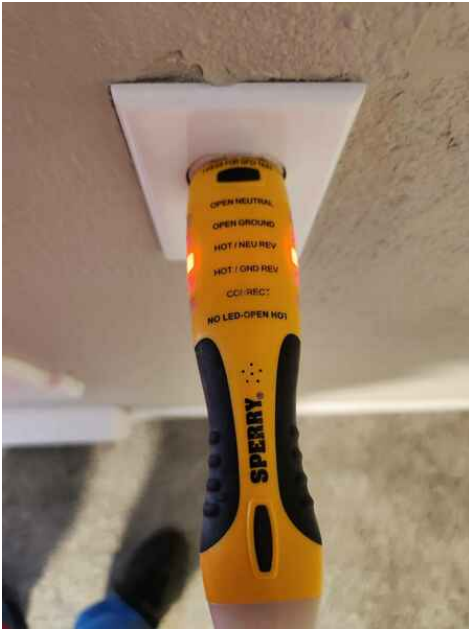
10.6.1 Lighting Fixtures,
Switches & Receptacles

REVERSE POLARITY

One or more receptacles have been wired with reverse polarity. This can create a shock hazard. Recommend licensed electrician evaluate & repair.

Contact a qualified electrical contractor.

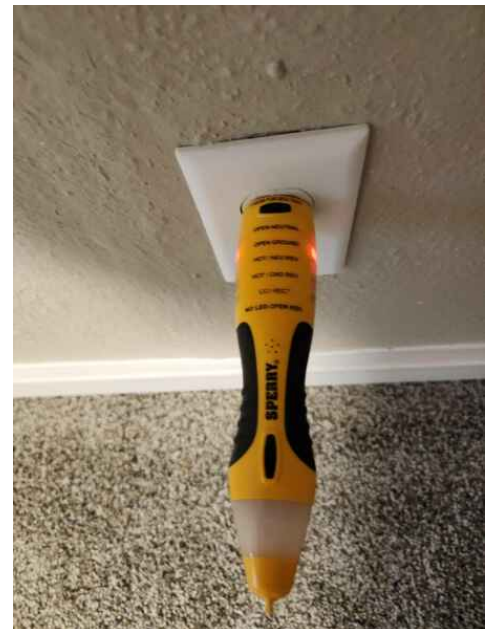
10.6.2 Lighting Fixtures, Switches & Receptacles

UNGROUND RECEPTACLE

One or more receptacles are ungrounded. This is a **Safety Defect**.
Recommend repair as needed.

Contact a handyman or DIY project

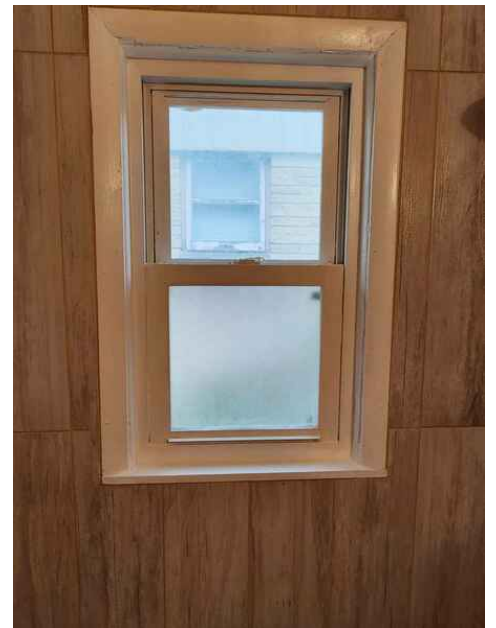
11.8.1 Windows

WINDOW PAINTED SHUT

At the time of inspection the Bathroom window was painted shut and would not open. Recommend repair as needed.

Contact a handyman or DIY project

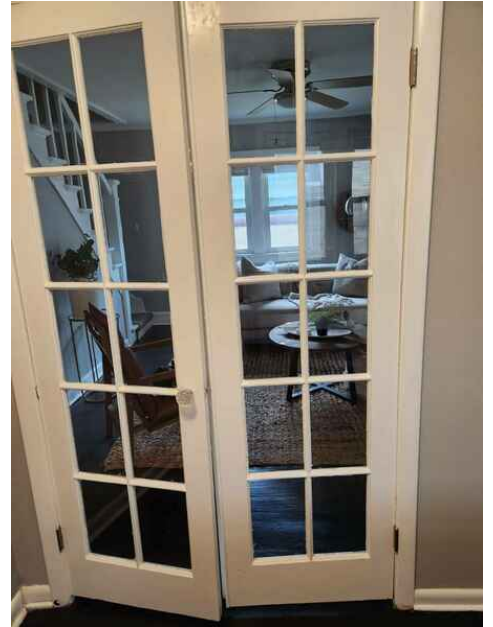
The door will not close properly and wants to hang up. Recommend repair as needed.

Contact a handyman or DIY project

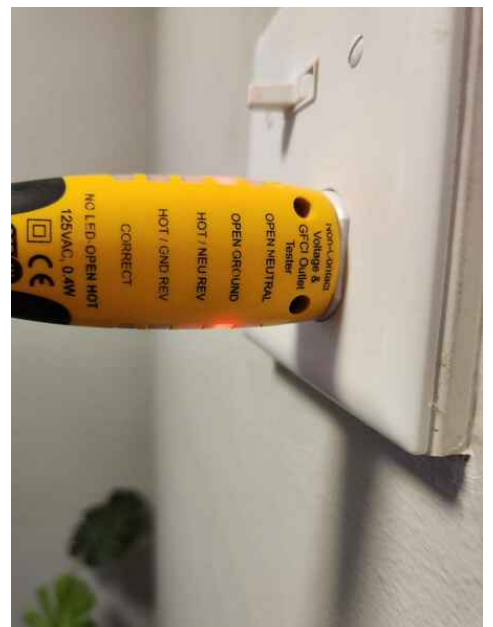
13.2.1 Lighting Fixtures, Switches & Receptacles

UNGROUND RECEPTACLE

One or more receptacles are ungrounded. This is a **Safety Defect**. Recommend repair as needed.

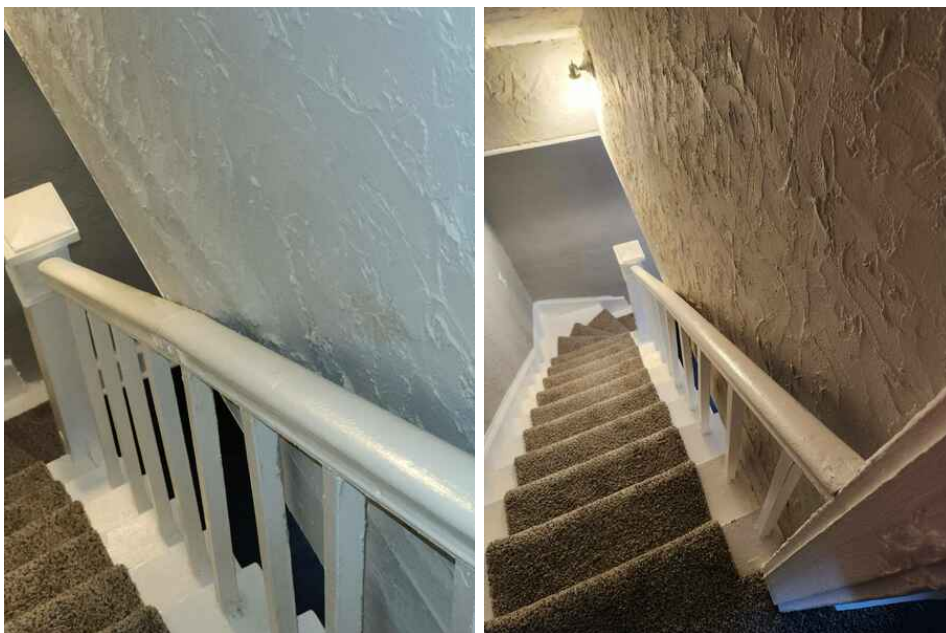
LOOSE / BROKEN HANDRAIL HARDWARE

The handrail going upstairs is loose and touching the wall. This takes away from the handrail being graspable. Recommend repair as needed.

Contact a handyman or DIY project

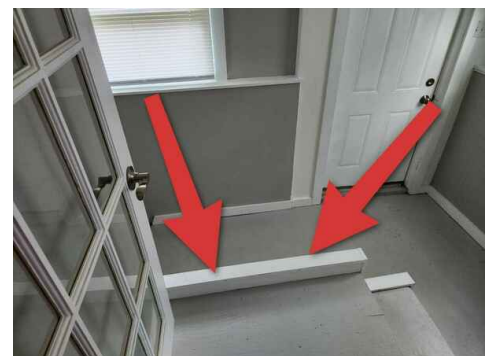
14.1.2 Steps, Stairways & Railings

NO RAILING

On the landing off the Kitchen does not have any railing. This is a **Safety Defect**. Recommend a railing be installed.

Contact a handyman or DIY project

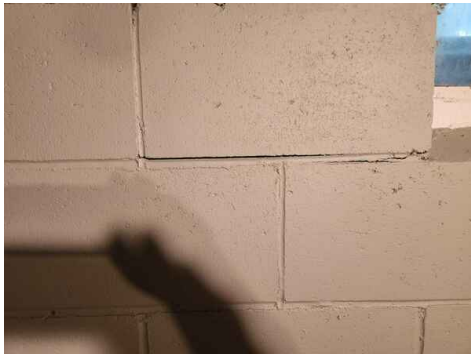
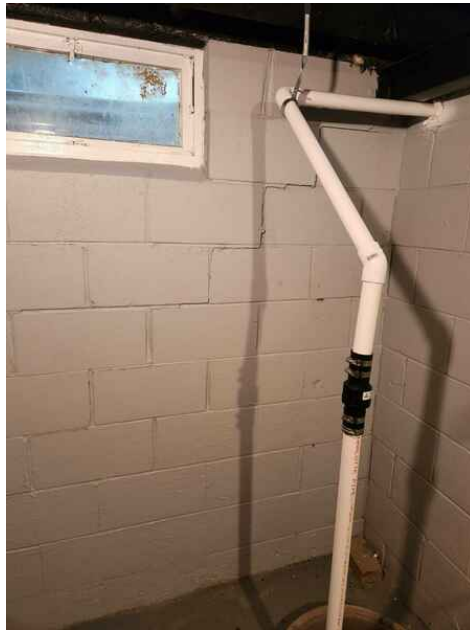
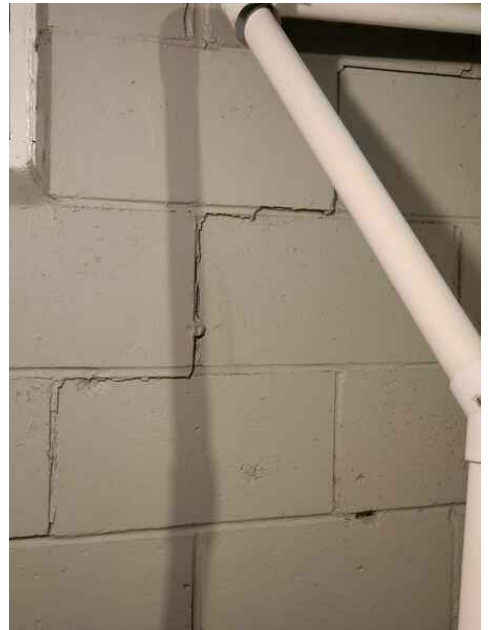
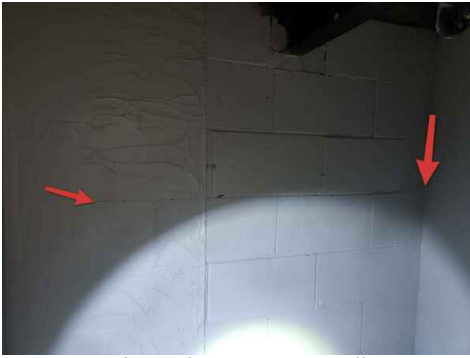
EVIDENCE OF STRUCTURAL DAMAGE

Evidence of structural damage was found in the wall structure. Recommend a structural engineer evaluate and advise on how to repair.

Same Wall as Step Crack with distortion

Step Crack with distortion

Step Crack with Distortion

Horizontal Crack on Front Wall

Contact a qualified structural engineer.

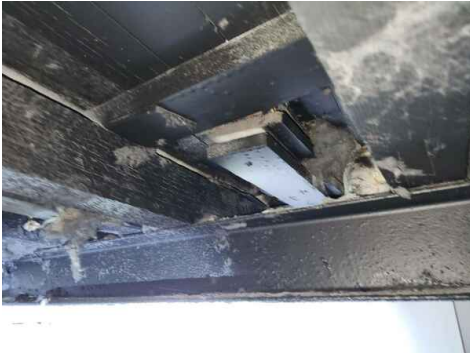
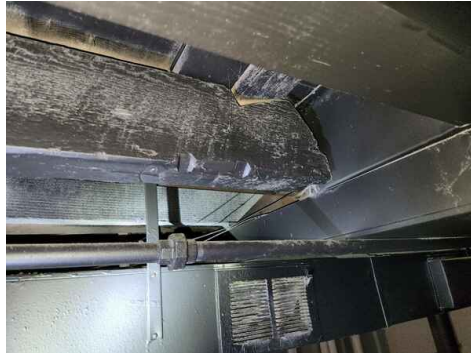
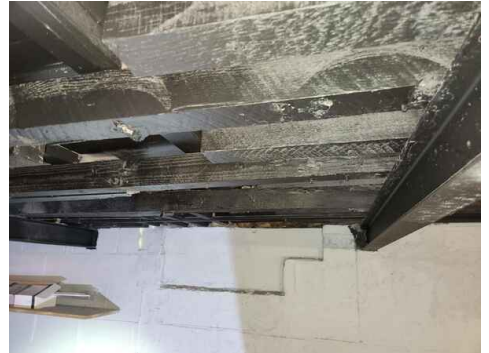
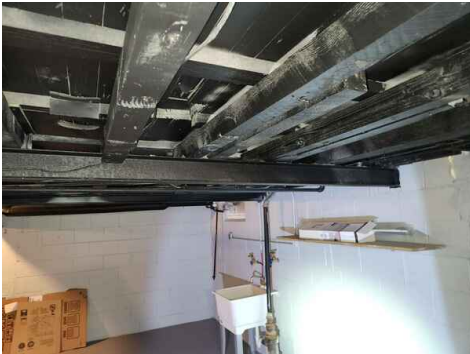
16.7.1 Joists

The joist in the Basement are properly supported or terminated. Also, some are not properly attached (joist sistering) together. Recommend further evaluation by a licensed Structural Engineer.

Contact a qualified structural engineer.

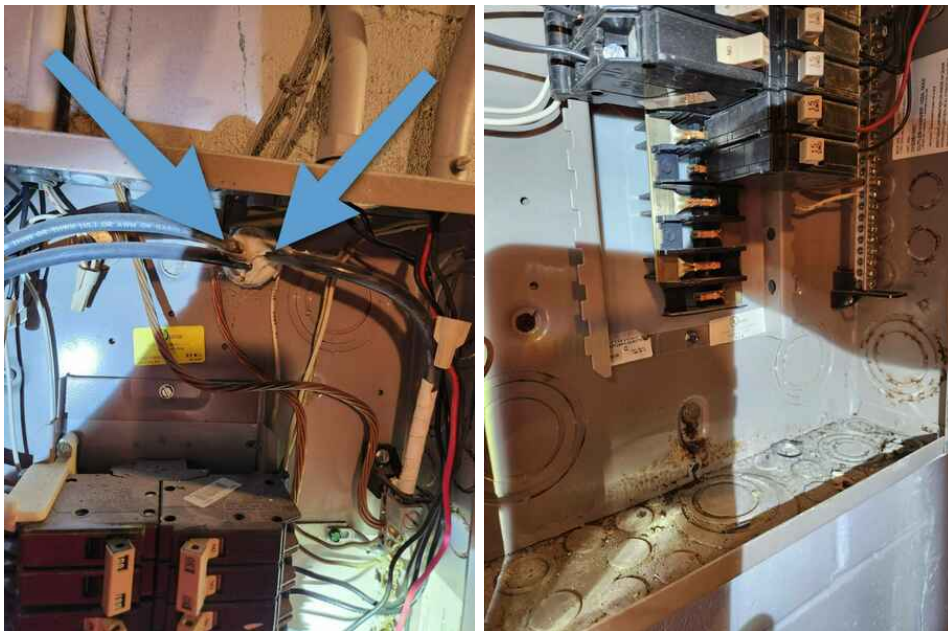
CONDENSATION RUST INSIDE PANEL

The inside of the Main Electrical has signs of condensation rust. The main service wires coming into the electrical panel have been sealed to avoid any further potential condensation to form. Recommend continued monitoring.

Recommend monitoring.

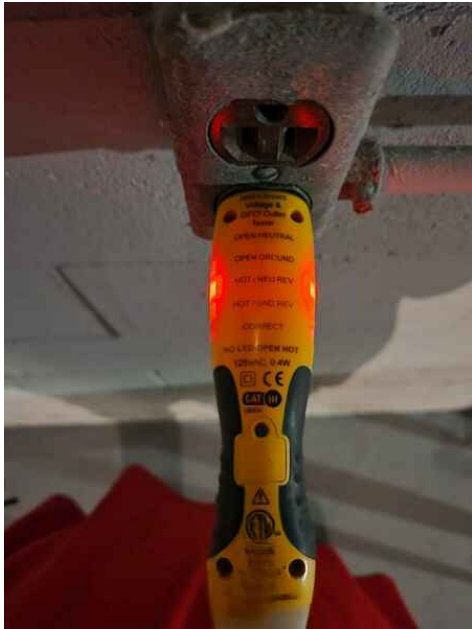
17.1.2 Main Panel

One or more receptacles have been wired with reverse polarity. This can create a shock hazard. Recommend licensed electrician evaluate & repair.

Contact a qualified electrical contractor.

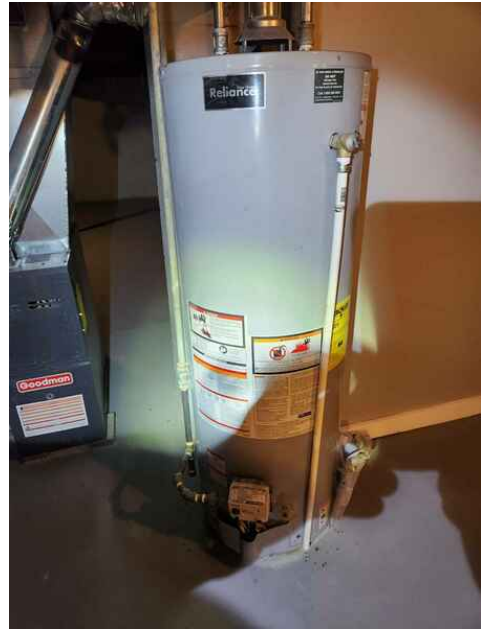
UNABLE TO DETERMINE

Unable to determine capacity, model number, serial number, nor age. At the time of the inspection the information label had been removed.

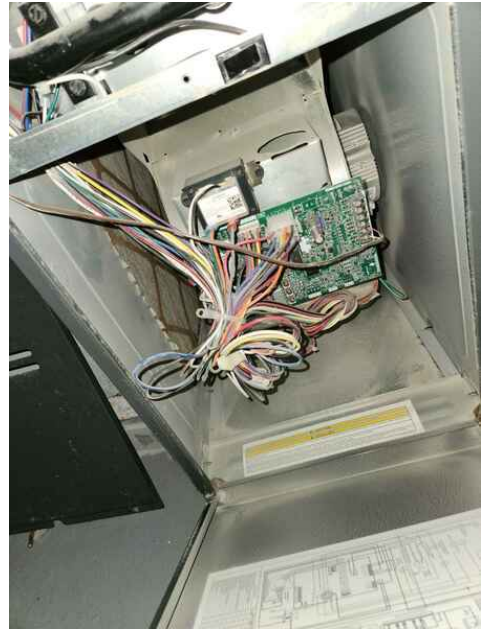
The furnace filter is dirty and needs to be replaced every 6 months.

Furnace should be cleaned and serviced annually. Recommend a qualified HVAC contractor clean, service and certify furnace.

Contact a qualified HVAC professional.
